Main Water System

TEST RESULTS BY WATER QUALITY ZONE

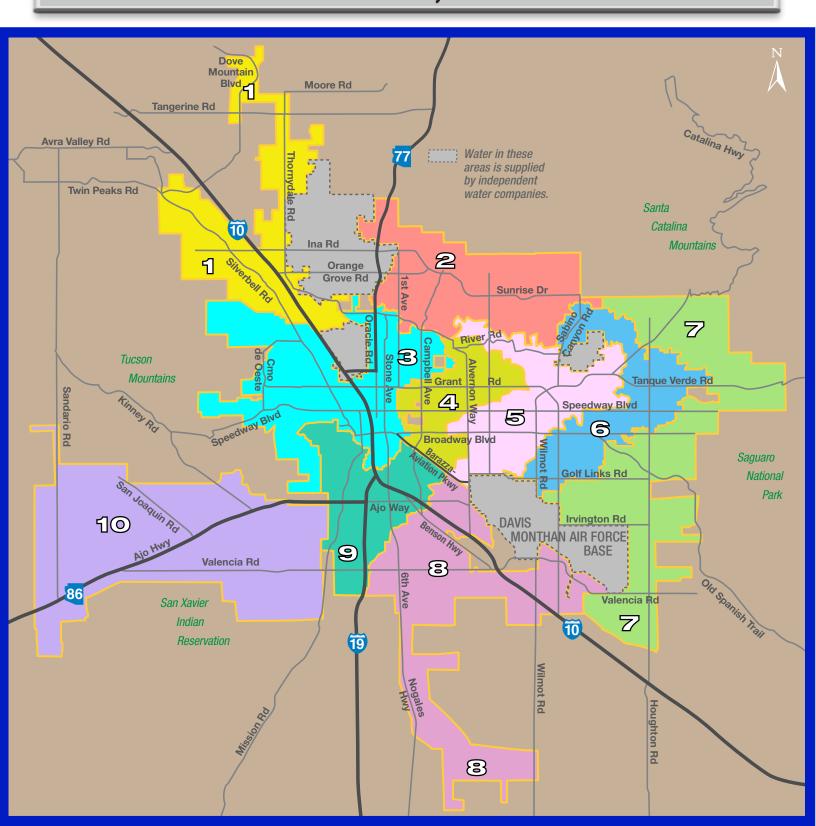
To ensure your tap water is safe, clean and secure, Tucson Water conducts approximately 14,500 individual tests each year on the water in the main distribution system — before it reaches your home. Test results for key parameters are reported by 10 water quality zones for a water distribution system that covers some 375 square miles.
